GATEWAY TO THE CIVIC CENTER

United Nations Plaza Renovation

PRESENTATION OF FINDINGS

*Prepared for the San Francisco Board of Supervisors' UN Plaza Working Group
by ROMA Design Group and the San Francisco Department of Public Works*

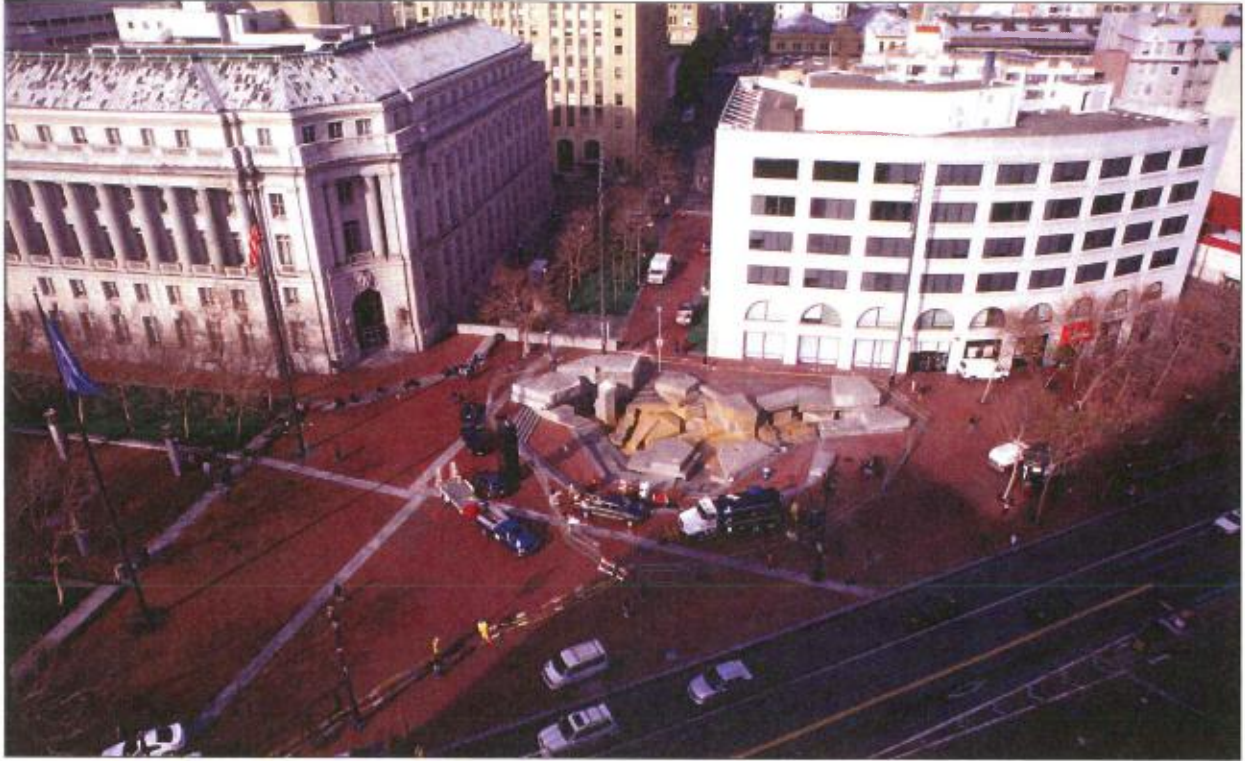
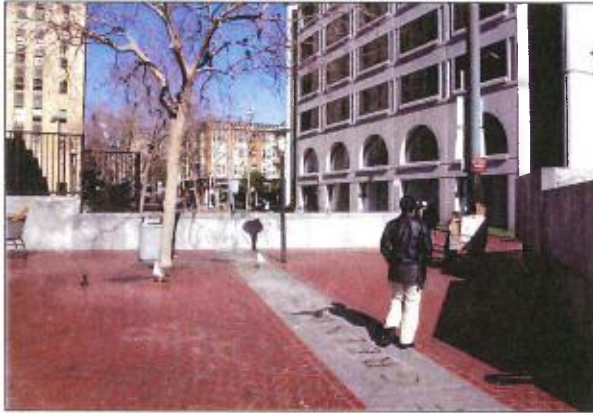
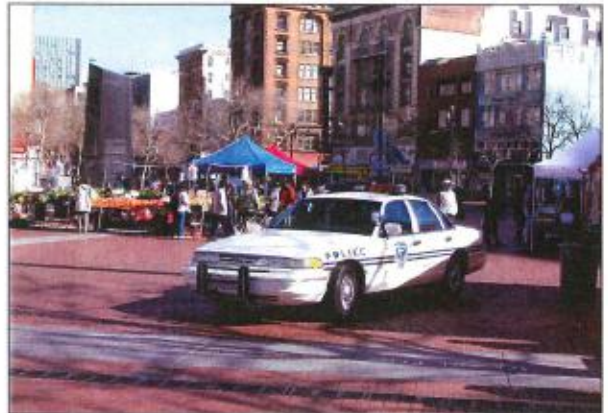
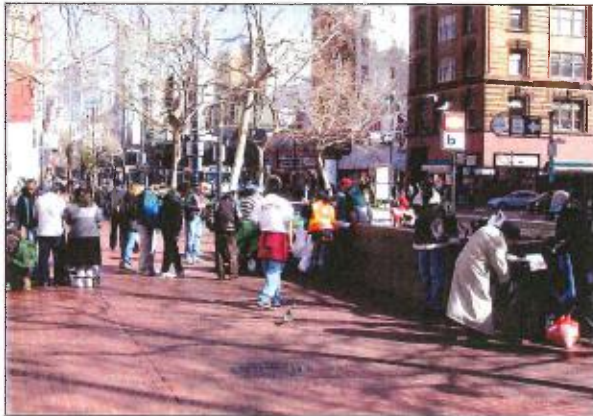
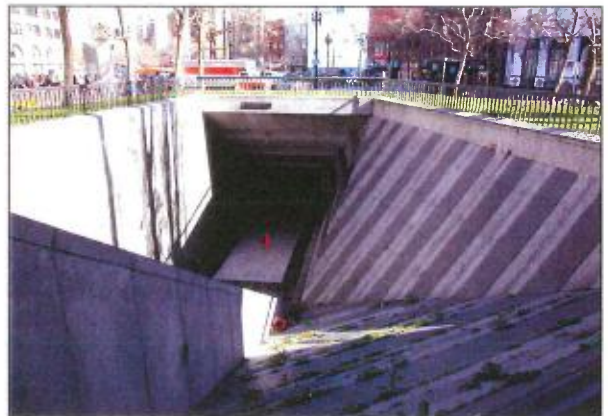
Existing Conditions

More specifically, the following physical characteristics were identified as having detrimental effects on the viability of United Nations Plaza as a public space:

- Rather than enhancing the role of Fulton Street, the creation of a plaza at the intersection with Market Street actually diminished the Beaux Arts intentions to connect the Civic Center with Market Street and by extension to the Ferry Building. Further it tended to isolate the programmed events within Fulton Street from Market Street. The closure of Fulton Street undermined its role as a gateway and arrival into the Civic Center.

- The large pedestrian areas, particularly adjacent to the BART entrances eliminated opportunities for drop-off and pick-up by transit, taxis and other modes which would enhance the viability of transit to serve a broader market. In this manner, they further diminished the opportunity for the common everyday activities that serve to enliven a place and make the station areas feel more secure.

- The placement of the fountain adjacent to the Leavenworth corridor created a “backside” to the plaza and eliminated an essential connection for the neighborhood. The walls of the adjacent buildings further diminished the role of Leavenworth as a connection to the adjacent neighborhood, and exacerbated the accumulation of trash and garbage in and around the fountain area.

- The use of the terminus of Leavenworth Street as a service corridor providing vehicular access only to the federal building without a designated pedestrian pathway diminishes the role of the street as a linking element and contributes to the sense of isolation between the neighborhoods to the north and the plaza.

- The placement of the Simon Bolivar statue in the center of Fulton Street does not contribute to the visual and physical linkage to City Hall.
- The high light levels on the illuminated pylons along Fulton Street create glare and contrast and the implicit message that this is not a safe area to be in at night.

- The parterres of green grass interrupt flows of pedestrian movement and limit the space for markets and other events.
- The grassy berm and chasm-like quality of the central BART station entrance does not create an attractive appearance. Rather than providing continuity to activity, the grassy berm creates buffers to the BART entrance and further isolate it from the surrounding plaza.
